HOME REPORT

FLAT 2 WESTGATE, 3 HIGH STREET, NAIRN, IV12 4AG

SINGLE SURVEY

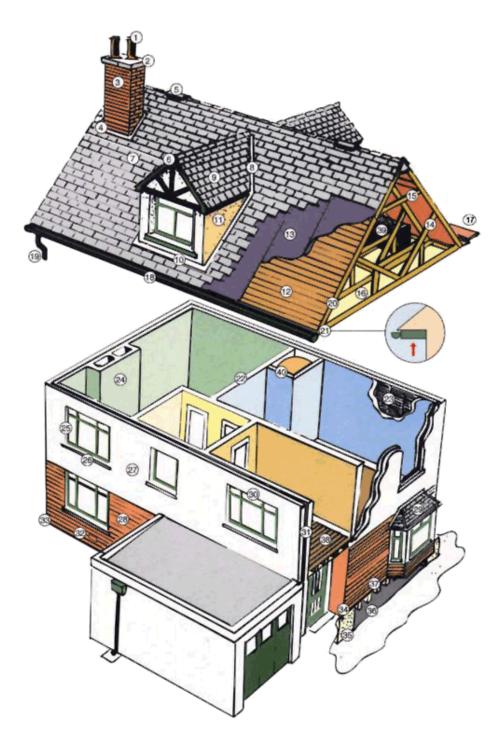
Sectional Diagram showing elements of a typical house

Reference may be made in this report to some or all of the above component parts of the property. This diagram may assist you in locating and understanding these items.

- 1) Chimney pots
- 2) Coping stone
- 3) Chimney head
- 4 Flashing
- 5) Ridge ventilation
- 6 Ridge board
- 7) Slates / tiles
- 8 Valley guttering
- 9 Dormer projection
- 10 Dormer flashing
- 11) Dormer cheeks
- (12) Sarking
- (13) Roof felt
- (14) Trusses
- (15) Collar
- 16 Insulation
- (17) Parapet gutter
- (18) Eaves guttering
- 19) Rainwater downpipe
- 20) Verge boards/skews
- 21) Soffit boards
- 22) Partition wall
- 23) Lath / plaster
- 24) Chimney breast
- 25) Window pointing
- 6) Window sills
- 27) Rendering
- (28) Brickwork / pointing
- 29) Bay window projection
- 30 Lintels
- (31) Cavity walls / wall ties
- 32) Subfloor ventilator
- 33 Damp proof course
- 34) Base course
- (35) Foundations
- 36) Solum
- 37) Floor joists
- 38) Floorboards
- 39) Water tank
- 40) Hot water tank
