# Home Report

Ben View 40 Stuart Street  
Ardersier Inverness IV2 7RU

# single survey

<b>Property address</b>	Ben View 40 Stuart Street Inverness IV2 7RU
<b>Customer</b>	Niall Macleod
<b>Prepared by</b>	Graham + Sibbald LLP

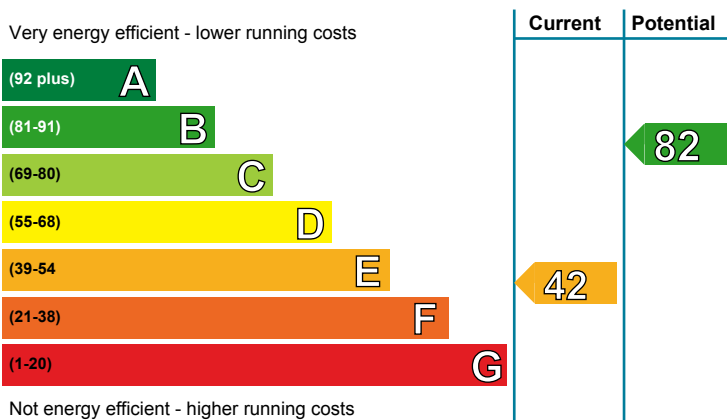
## Energy Efficiency Rating

This graph shows the current efficiency of your home, taking into account both energy efficiency and fuel costs. The higher this rating, the lower your fuel bills are likely to be.

Your current rating is **band E (42)**. The average rating for EPCs in Scotland is **band D (61)**.

The potential rating shows the effect of undertaking all of the improvement measures listed within your recommendations report.
