# Home Report

Brackla Wood Culbokie  
Dingwall IV7 8GY

# single survey

<b>Property address</b>	Brackla Wood Culbokie Dingwall IV7 8GY
<b>Customer</b>	Susan & Ian Dudgeon
<b>Prepared by</b>	Graham + Sibbald LLP

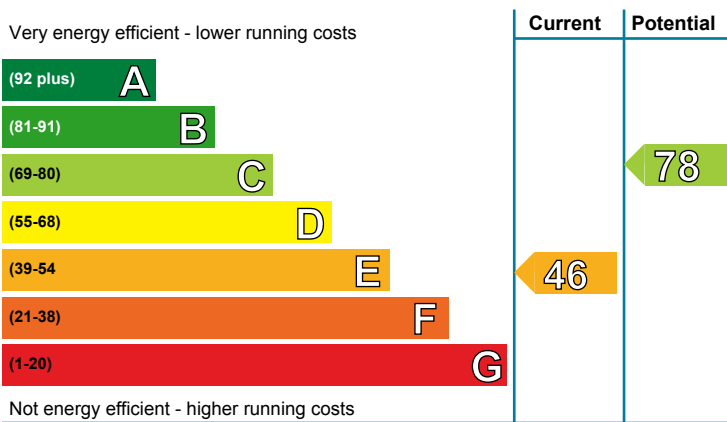
## Energy Efficiency Rating

This graph shows the current efficiency of your home, taking into account both energy efficiency and fuel costs. The higher this rating, the lower your fuel bills are likely to be.

Your current rating is **band E (46)**. The average rating for EPCs in Scotland is **band D (61)**.

The potential rating shows the effect of undertaking all of the improvement measures listed within your recommendations report.
