# Home Report

42 Beech Avenue  
Nairn IV12 4SY

Date of Valuation: 26/09/2024

<b>Property address</b>	42 Beech Avenue Nairn IV12 4SY
<b>Customer</b>	Kate Donald
<b>Prepared by</b>	Graham + Sibbald LLP

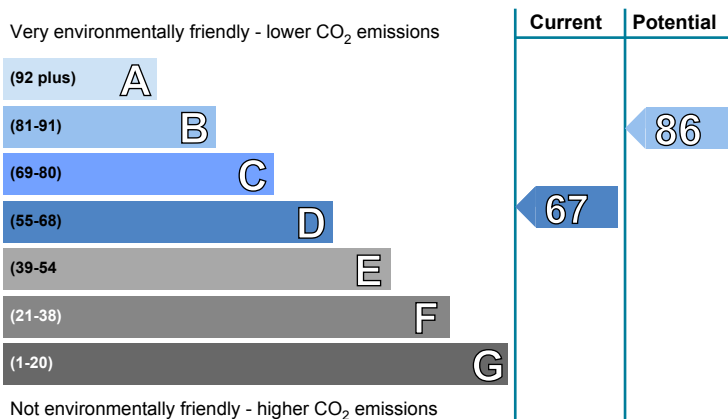
## Environmental Impact (CO<sub>2</sub>) Rating

This graph shows the effect of your home on the environment in terms of carbon dioxide (CO<sub>2</sub>) emissions. The higher the rating, the less impact it has on the environment.
