HOME REPORT

1 TEMPLE CRESCENT, INVERNESS, IV2 4UR

Dwelling type: End-terrace house
Date of assessment: 25 October 2024
Date of certificate: 30 October 2024
Total floor area: 125 m²
Primary Energy Indicator: 280 kWh/m²/year

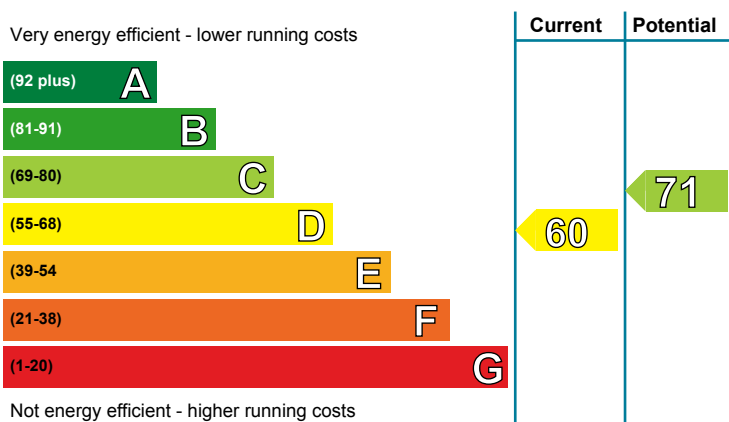
Energy Efficiency Rating

This graph shows the current efficiency of your home, taking into account both energy efficiency and fuel costs. The higher this rating, the lower your fuel bills are likely to be.

Your current rating is **band D (60)**. The average rating for EPCs in Scotland is **band D (61)**.

The potential rating shows the effect of undertaking all of the improvement measures listed within your recommendations report.

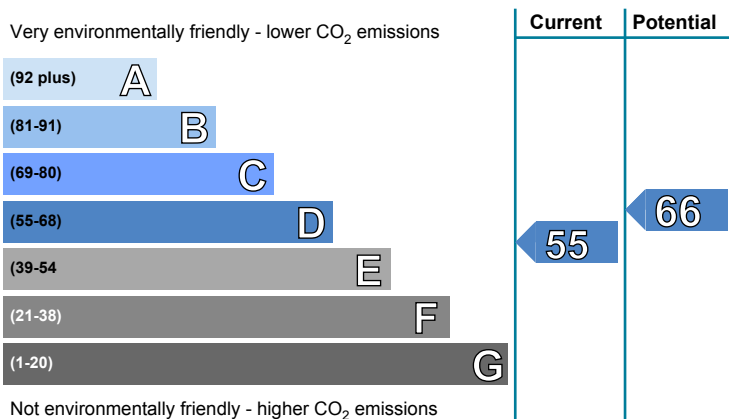
Environmental Impact (CO₂) Rating

This graph shows the effect of your home on the environment in terms of carbon dioxide (CO₂) emissions. The higher the rating, the less impact it has on the environment.

Your current rating is **band D (55)**. The average rating for EPCs in Scotland is **band D (59)**.

The potential rating shows the effect of undertaking all of the improvement measures listed within your recommendations report.
