Home Report

19 Upper Kessock Street Inverness IV3 8HF

single survey

survey report on:

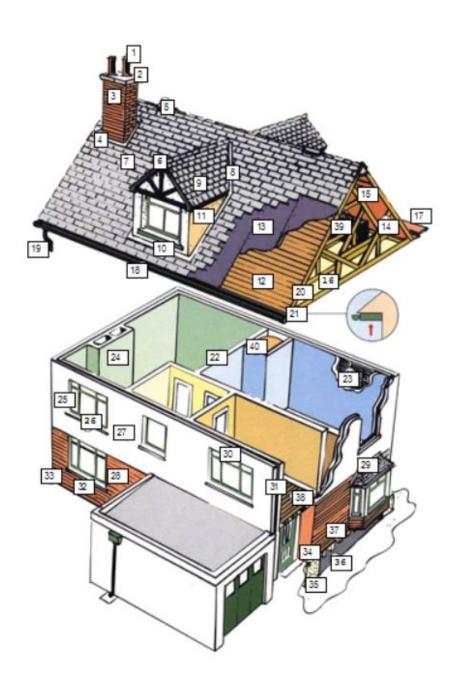
Sectional Diagram showing elements of a typical house

- 1 Chimney pots
- 2 Coping stone
- 3 Chimney head
- 4 Flashing
- 5 Ridge ventilation
- 6 Ridge board
- 7 Slates/tiles
- 8 Valley guttering
- 9 Dormer projection
- 10 Dormer flashing
- 11 Dormer cheeks
- 12 Sarking
- 13 Roof felt
- 14 Trusses
- 15 Collar
- 16 Insulation
- 17 Parapet gutter
- 18 Eaves guttering
- 19 Rainwater downpipe
- 20 Verge boards / skews
- 21 Soffit boards
- 22 Partition wall
- 23 Lath / plaster
- 24 Chimney breast
- 25 Window pointing
- 26 Window sills
- 27 Rendering
- 28 Brickwork / pointing
- 29 Bay window
 - projection
- 30 Lintels
- 31 Cavity walls / wall ties
- 32 Subfloor ventilator
- 33 Damp proof course
- 34 Base course
- 35 Foundations
- 36 Solum
- 37 Floor joists
- 38 Floorboards
- 39 Water tank
- 40 Hot water tank

Reference may be made in this report to some or all of the above component parts of the property. This diagram may assist you in locating and understanding these items.
