# Home Report

10 Bught Drive  
Inverness IV3 5ST

# Single Survey

<b>Property Address</b>	10 Bught Drive Inverness IV3 5ST
<b>Customer</b>	Vaila Morrison
<b>Prepared by</b>	Graham + Sibbald LLP
<b>Date of Inspection</b>	17/02/2025

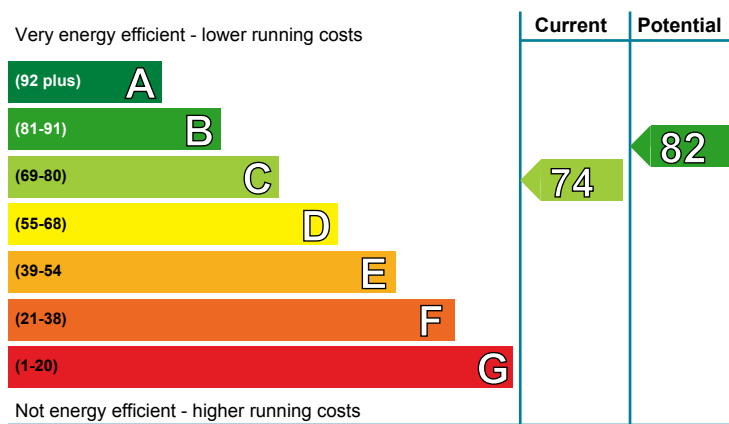
## Energy Efficiency Rating

This graph shows the current efficiency of your home, taking into account both energy efficiency and fuel costs. The higher this rating, the lower your fuel bills are likely to be.

Your current rating is **band C (74)**. The average rating for EPCs in Scotland is **band D (61)**.

The potential rating shows the effect of undertaking all of the improvement measures listed within your recommendations report.

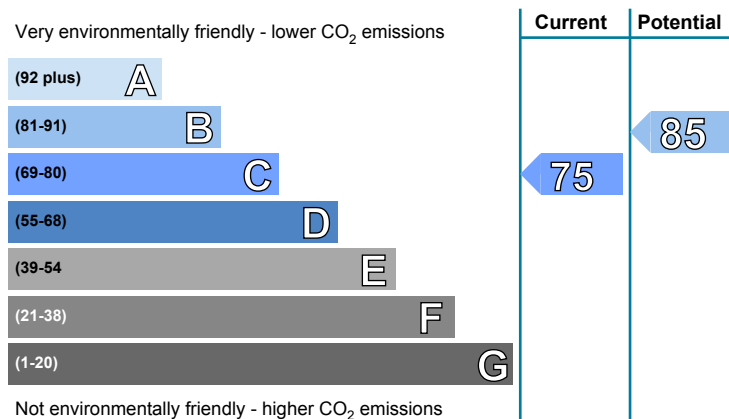
## Environmental Impact (CO<sub>2</sub>) Rating

This graph shows the effect of your home on the environment in terms of carbon dioxide (CO<sub>2</sub>) emissions. The higher the rating, the less impact it has on the environment.
