Home Report

22 Warrand Road
Inverness IV3 5SH

Single Survey

| Description | The property comprises a first floor flat within a three storey block comprising a total of six apartments. |

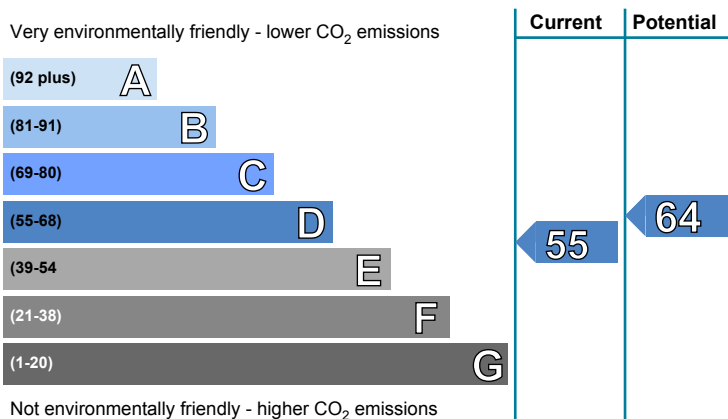
Environmental Impact (CO₂) Rating

This graph shows the effect of your home on the environment in terms of carbon dioxide (CO₂) emissions. The higher the rating, the less impact it has on the environment.
